Substructure Cathodic Protection in Ontario: Field Trials 1982-1986

Ontario
Ministry of Transportation and Communications
Research and Development Branch

D.G. Manning
Principal Research Engineer

May 1987

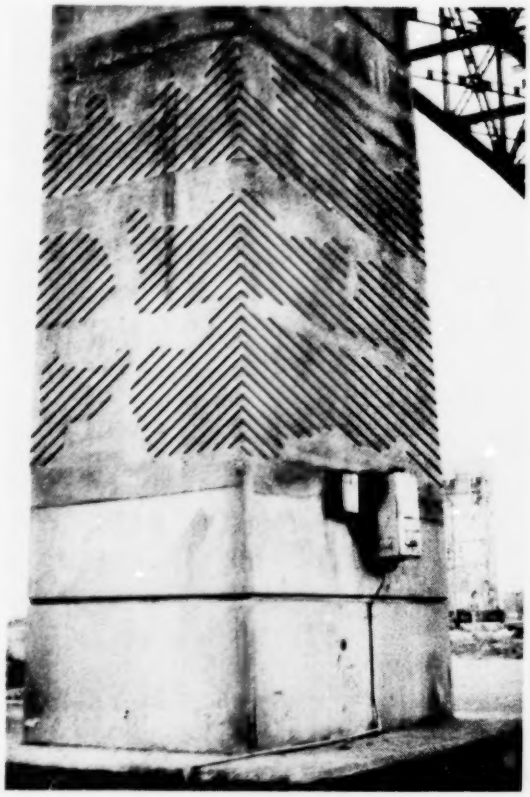
Figure 1/ System 5, Burlington Bay Skyway Test Site

As noted in the previous publications, debonding of the shotcrete from the underlying concrete proved to be a problem in all of the impressed current systems with shotcrete overcoats. In all cases, areas of debonding increased with time as the systems operated. Alligator cracking developed over the shotcrete surface. Figure 1 illustrates the extent of debonding detected by sounding System 5 three years after installation. When this system was

sounded one month after installation, only one very small delamination was present. Figure 2, showing large pieces of shotcrete removed intact from System 3 in 1985, illustrates the lack of bond with the base concrete.

By mid 1986, paint had been almost entirely removed from the surfaces of Systems 2 and 8 by weathering, to the extent that both systems had effectively failed. The extent of the degradation of System 8, three years after installation, is shown in Figure 3. The materials were not sufficiently durable to withstand the harsh climate and exposure to salt-laden run-off which are typical of the Ontario highway environment.

The shaded area indicates the extent of debonding of the shotcrete overcoat three and a half years after installation.

Figure 2/ System 3, Burlington Bay Skyway Test Site

Removal of the shotcrete overcoat in 1985 is shown. The lack of bond between the shotcrete and underlying concrete is indicated by the very large piece of shotcrete removed intact. The carbon fiber secondary anode is visible.

Figure 3/ System 8, Burlington Bay Skyway Test Site

Three years after installation, almost all traces of the conductive paint anode, with its white latex overcoat, have been removed by weathering.

In view of the uncertainty surrounding the cause of the debonding, together with the relatively high unit costs for small quantities of shotcrete and concerns for its appearance, a decision was made in 1983 to concentrate future efforts on testing of systems utilizing exposed anodes or thin mortar coatings rather than anodes which required a shotcrete overcoat.

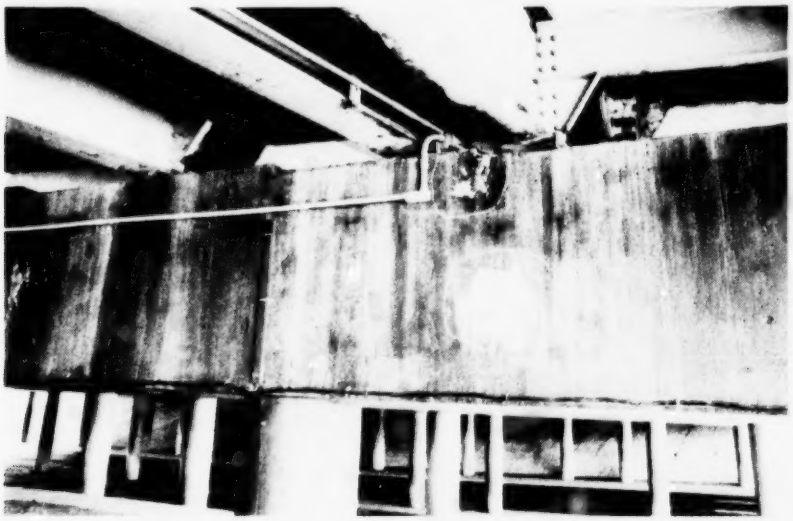
Figure 5/ Leslie Street Test Site

The conductive paint anode began to show visible deterioration within a few months of installation as small areas of paint debonded from the concrete. Initially the areas of deterioration did not appear to be directly related to the exposure conditions or to the chloride content of the concrete. In view of the experience at Burlington, it was decided to investigate whether current density was contributing to the damage. Accordingly the system was divided into two zones. One zone was operated at a slightly increased current density while the other zone was switched off. During the next year of operation in this configuration, the deterioration continued to increase with no significant difference between the two zones, indicating that current density was not the major factor in the debonding. However, as time passed, the paint in those areas subject to the greatest amount of leakage and weathering, deteriorated more rapidly, as illustrated in Figure 5. It is not clear whether the initial debonding of the paint and the long-term deterioration are interrelated, or result from different mechanisms.

It has not been possible to identify any differences in material composition or method of application between the paints used at the Leslie Street and Burlington sites. The marked difference in performance appears to be due to different conditions in the concrete environment and this aspect is the subject of further investigation. In view of the unsatisfactory performance of the paint at Leslie Street, criteria for site selection and the condition

Deterioration of the condition of the conductive paint anode in June 1985 is shown (about ten months after installation). Surface areas subject to leakage from the the deck above are visibly stained.

of the concrete at the time of application of the paint need to be developed before proceeding with further installations.

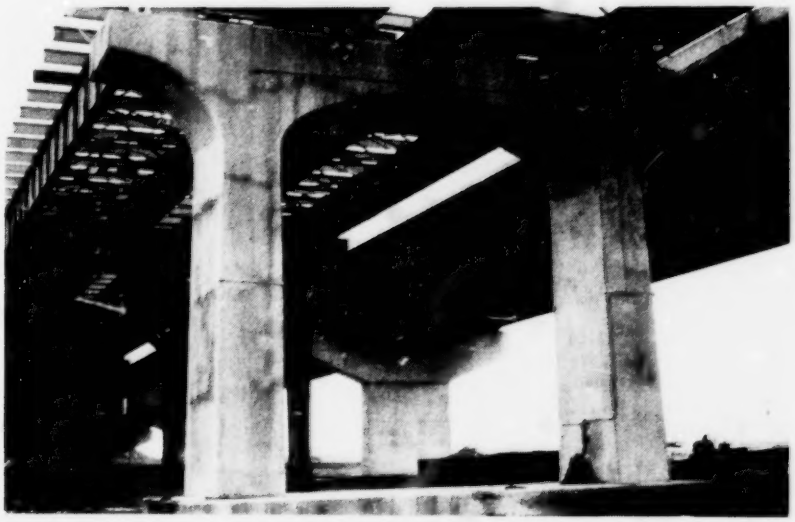
Figure 6/ Pier S16, Burlington Bay Skyway

The mesh anode was anchored in place with insulating fasteners. Figure 6 shows a roll of anode material being attached to the concrete surface. The anode material, which was designed for a lower current density than that installed the previous year, was very flexible and tended to curl and stretch at the edges. This meant additional anchors were required to secure the anode tightly against the concrete and the thickness of the overcoat was increased to cover the mesh. Both these items increased the cost of the installation considerably.

Attaching anode mesh (supplied in rolls 1.2 m wide x 61 m long) to the concrete surface.
